EXAMPLE BUYING ASSESSMENT

2020 Example Motors Demo Sedan Example

Customer: Example Buyer
Inspected: Oct 5, 2026

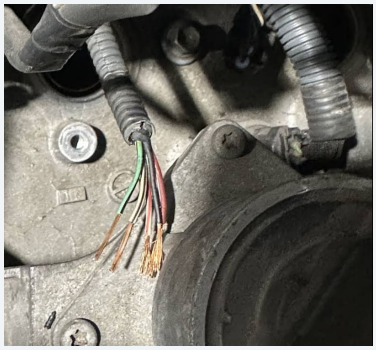
#91 Engine-bay wiring and connectors

CONCERN - HIGH

Example finding: damaged insulation at a visible engine connector. Have the circuit diagnosed and wiring repaired before purchase. Photo 03 is illustrative, not evidence from this vehicle.

PHOTO 03 - #91 Engine-bay wiring and connectors - Illustrative wiring concern (#91)
